Replacement of bellows

This was the case for 25 angular compensators installed in a district heating system in Germany.

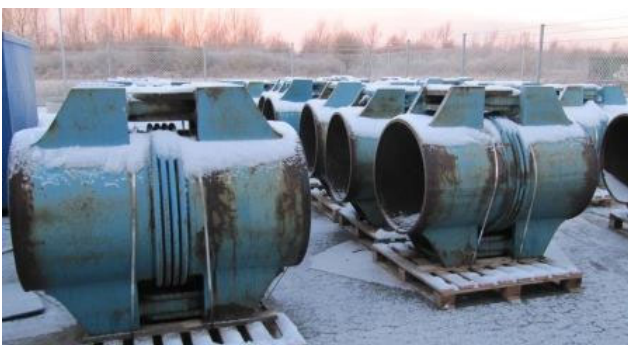
The compensators prior to repair

The replacement involved dismantling the old compensators, cutting out the old bellows and removing the pins. The old welded parts (welding ends with hinges and pins) were sandblasted and the old welds were cut off. Following this, they were ultrasonic inspected for stratification and checked for ovalization. The new bellows were welded in and the compensators were reassembled. All the old steel parts were then surface treated. Selected compensators were pressure tested at 48.8 bar (corresponding to a reaction force of over 234 tons). Finally, the compensators were packed and returned to the customer for refitting.
